PREPARED FOR:

Vincent Pundt

PREPARED BY: Homecheck Sample Phone 1-800-529-5121

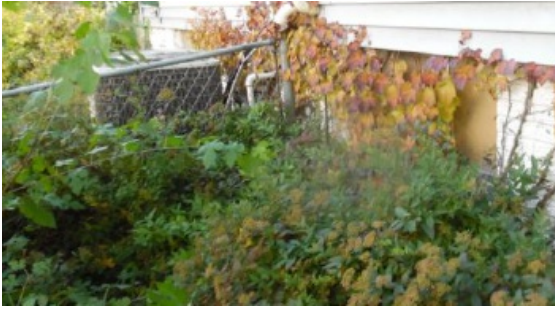
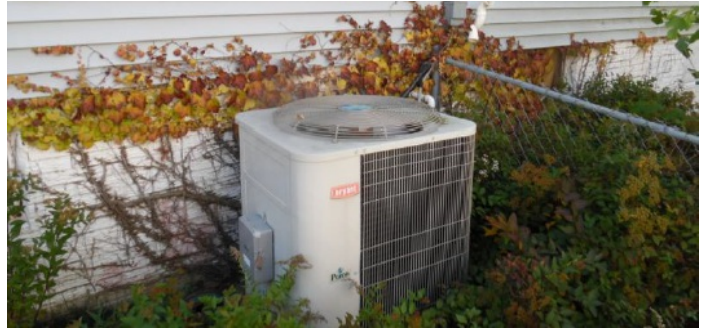
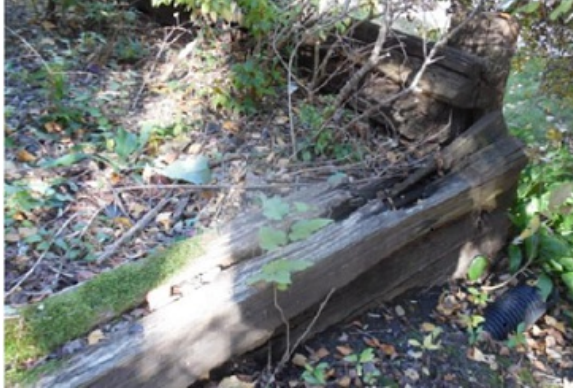
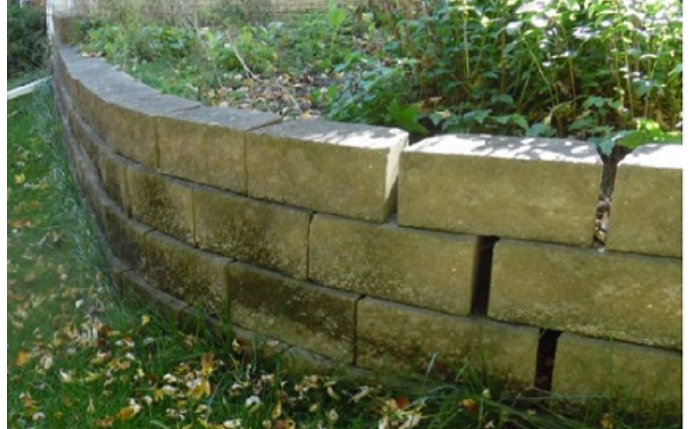
Marginal

The Air Conditioning needs to have Brush Removed from around the Unit. The Air Conditioning unit may be too close to the gas meter. '

There are 2 retaining walls on the property one on the side of the house and one in the back of the house. However Retaining Wall on the front side of the house needs repair with the Rail Road Ties.

Trees -Shrubberies - Vegetation: Trimming/ Removal Recommended

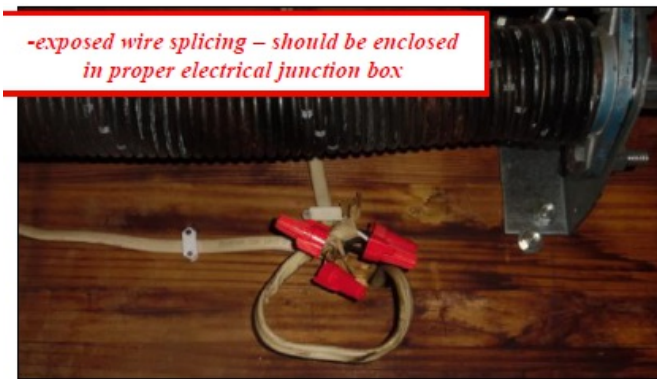
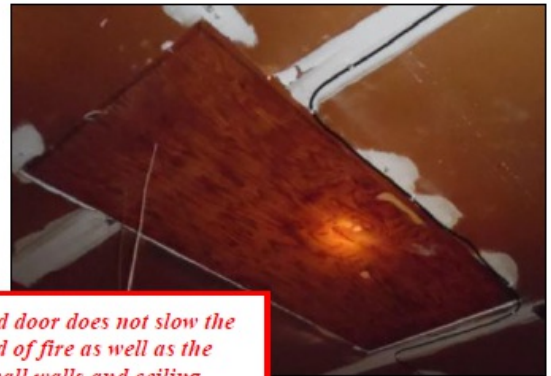
Safety Related Issue

The Garage has a metal Overhead door which is difficult to operate manually so that will need adjustment. The automatic door opener is working which is in good condition. The floor of the garage is concrete with

typical cracks because of settling. The exterior walk door was in good shape except the lock on the door was not operating normally. The electrical switches inside the Garage will need to be reviewed as a safety issue. There is a attic door above the garage car port that is made from plywood and should be replace by a fire prof door.

1. Garage door – difficult to raise in manual mode – recommend service/adjustment by a professional service Technician
2. Retaining walls – deterioration present at front (railroad tie wall) wall with replacement needed and rear block wall is leaning and in need of repair
3. Vegetation – vines, bushes & plant growth should be trimmed/removed to keep away from exterior walls of home to help minimize excess moisture and insect damage
4. Trim – damaged/deteriorated trim at front porch
5. Sump pump – leakage at outlet pipe above sump pit
6. Gutter – recommend installing additional gutter at east (front) fascia of upper roof to help alleviate excess water at window cut-outs directly below

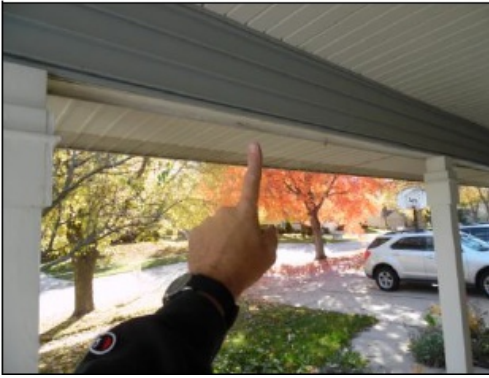
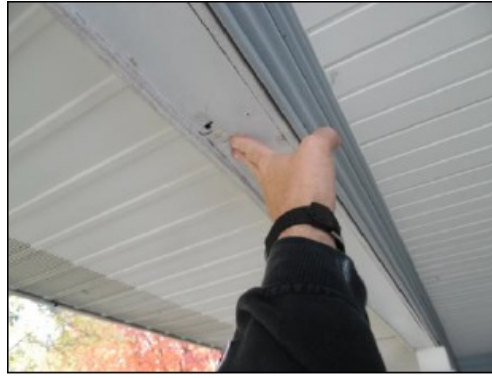
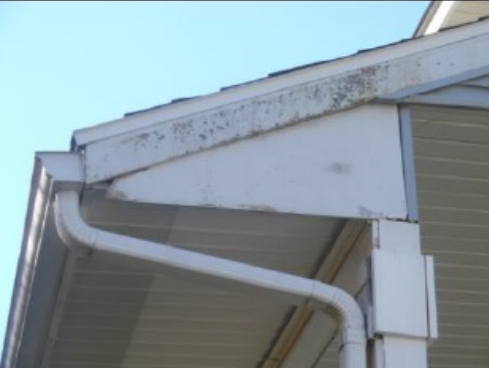
Patio is a concrete floor with wood columns that support a wood cover. There are a few areas of weathering that will need to be repaired.

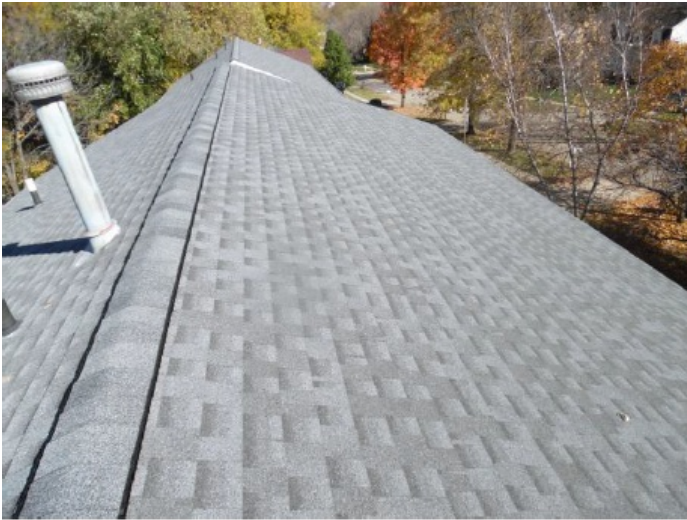
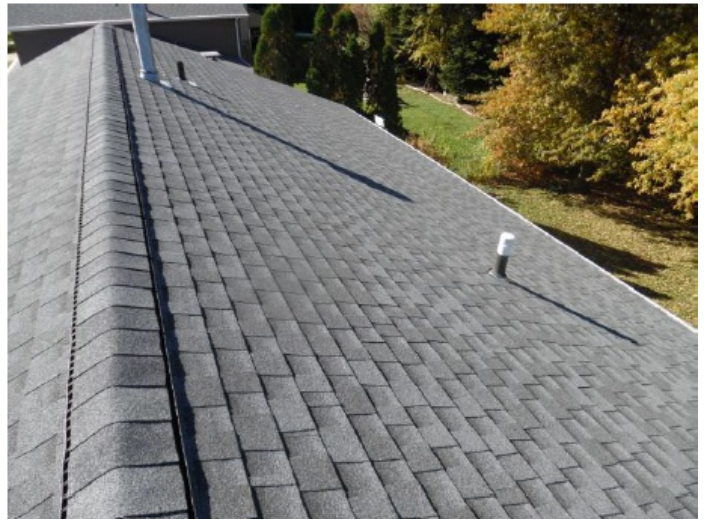
The Roof is around 8 to 9 years old and has width of 1 layer of material.

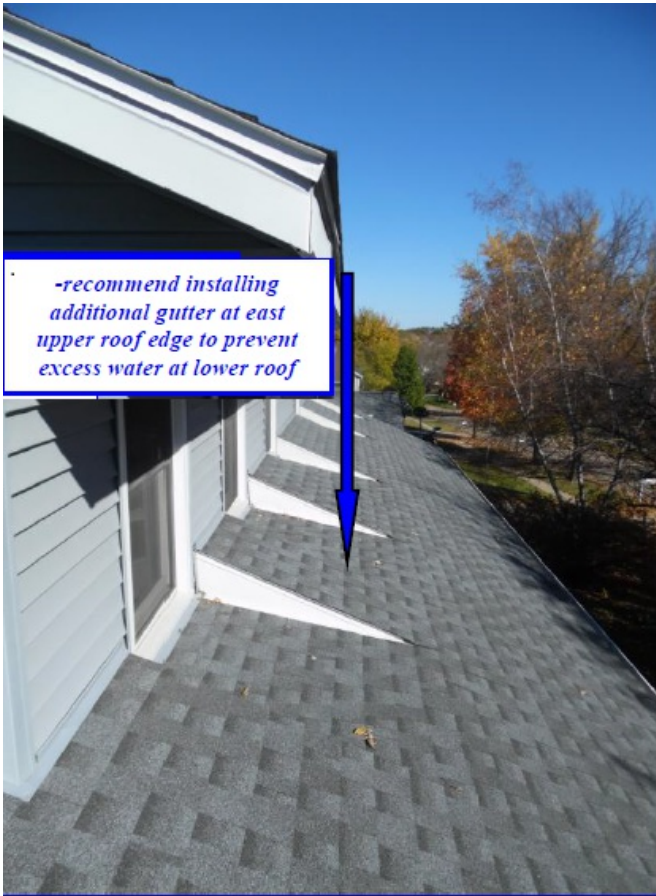
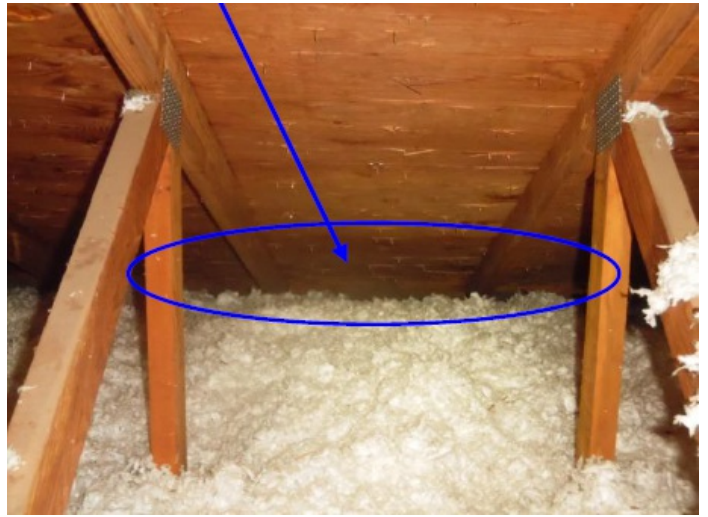
Roof Ventilation will need Baffles and eaves recommended. The Garage attic. No electrical was visible.

Cleaning needed on Gutters.

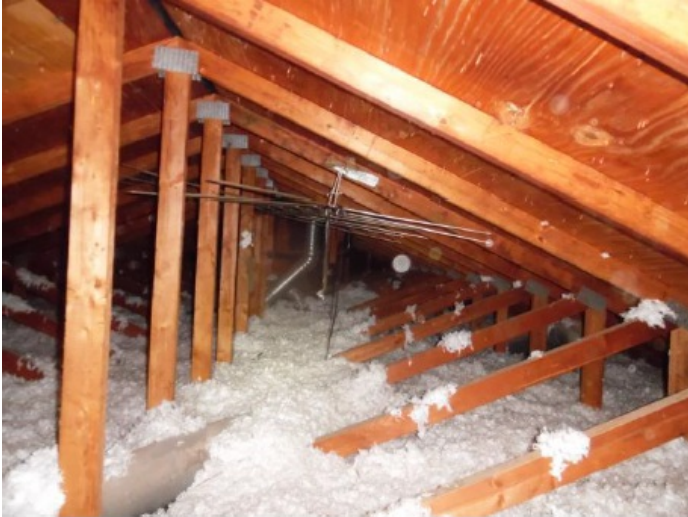
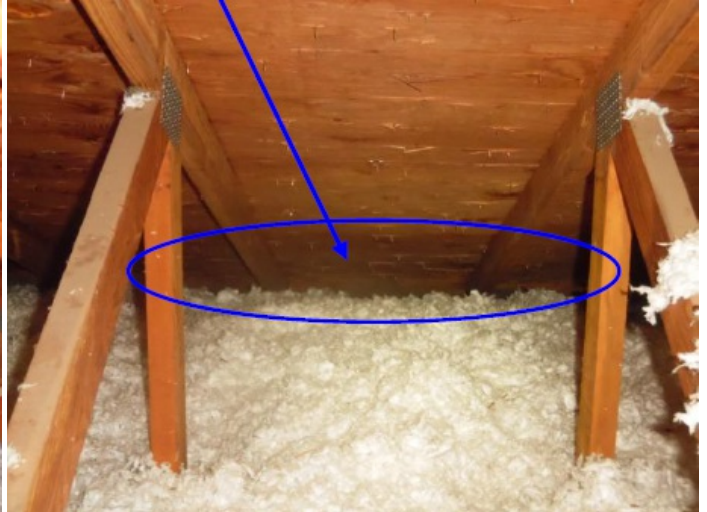
The Roof has a HVAC Duct and is built with Truss rafters of 2x4 wood. The sheathing is 3/8 plywood. and is Delaminated. The Depth of insulation is 12 to 14 inches.

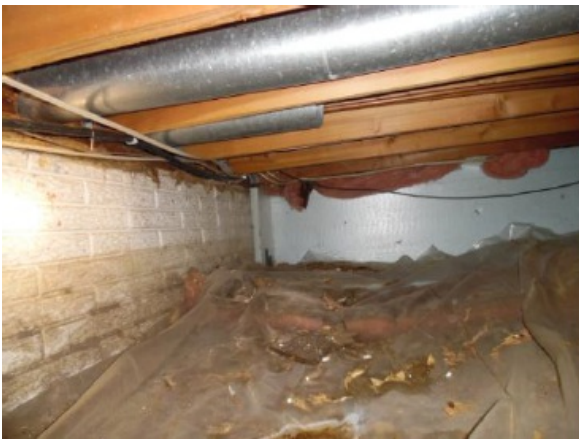
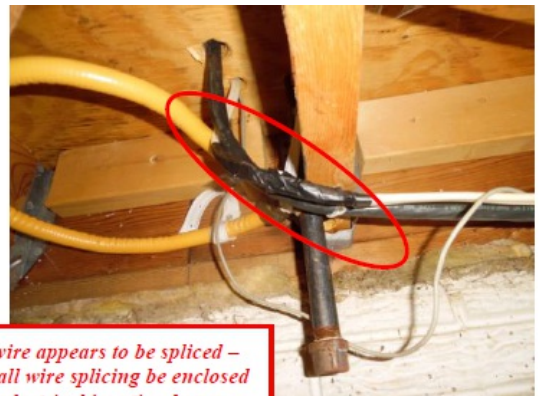
The floor of the crawl space is dirt and does not appear to have any signs of moisture. The ventilation does not appear present and the insulation on the floor is a plastic vapor barrier.

*-electrical wire appears to be spliced –
recommend all wire splicing be enclosed
in proper electrical junction boxes*

- o Exposed wire splicing in garage above garage door – recommend enclosing in proper junction box
 - o Appears to be exposed wire splicing (no junction box) in crawl space below kitchen stove (electrical tape wrap)

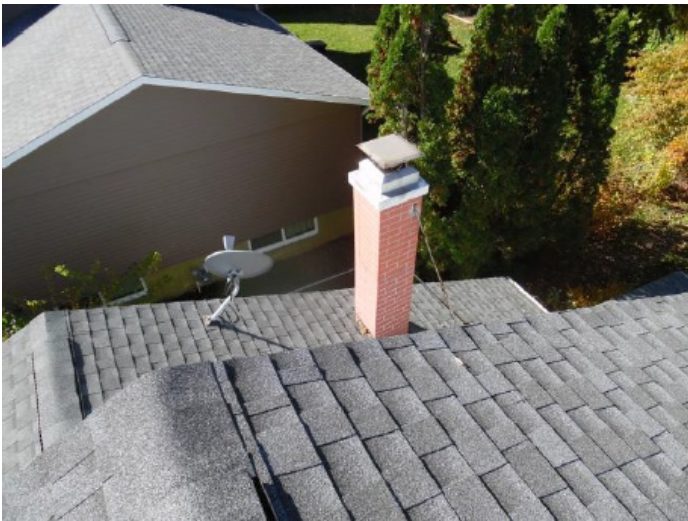
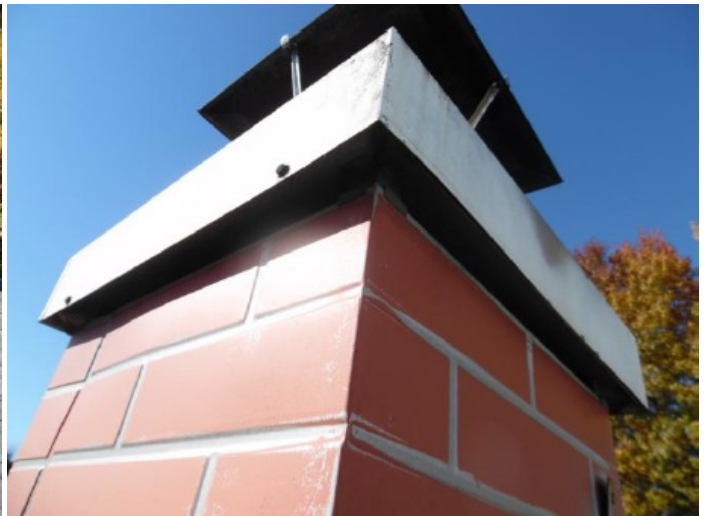
Marginal

The Chimney Chase is Satisfactory but a recommended evaluation and cleaning of the chimney by a certified chimney sweep the fireplace door is missing from inside.

5. Fireplace – recommend further evaluation/cleaning by a certified Chimney Sweep

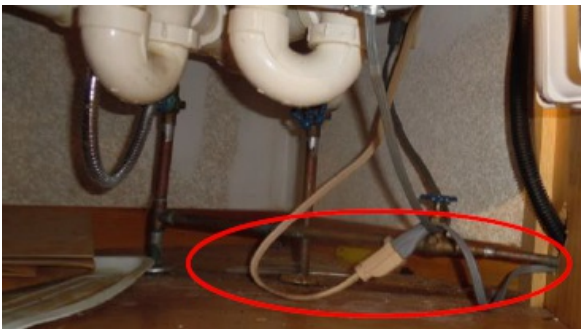
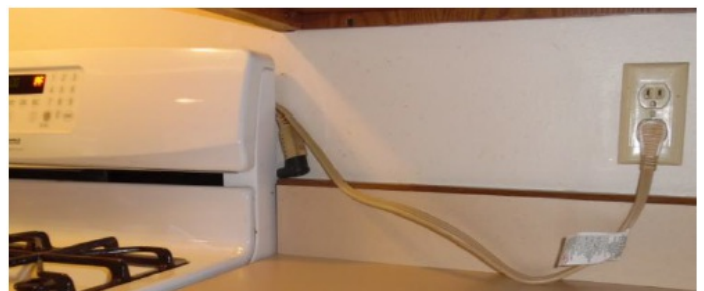
Marginal

The electrical outlets in the kitchen need to have GFCI devices. Safety related issue to remove the the lose power cord on the counter and have a dedicated 120 volt receptacle added to the back of the stove. In addition the right side of the bay window above the sink does not open.

- o Drop cord wiring on kitchen stove and dishwasher due to lack of proper 120 V outlet location
2. Plumbing trap – laundry sink appears to be missing trap to help protect from harmful sewer gas infiltration into home

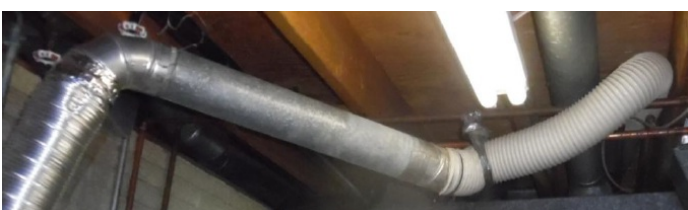
The Clothes Dryer vent is made from plastic and it should be metal as it is vented through the wall. This would need to be replaced. The dry has a 240 Volt electrical connection and is gas.

3. Dryer venting – recommend cleaning and replacement of plastic material
4. Window – living room window nearest NE corner of room has malfunctioning counter balance (sash falling when raised)

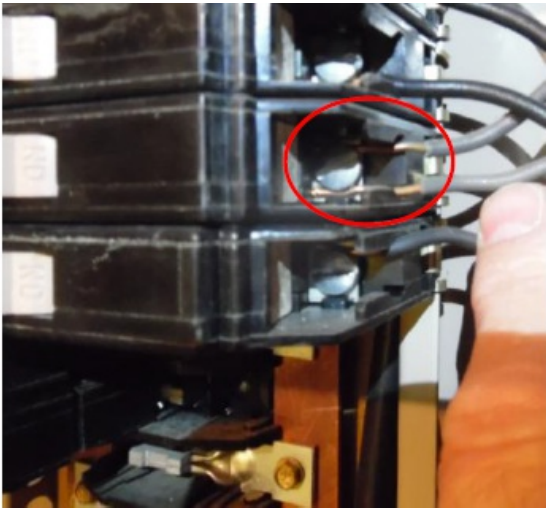
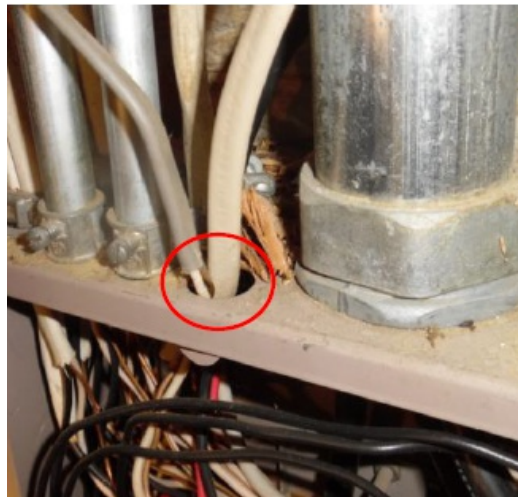
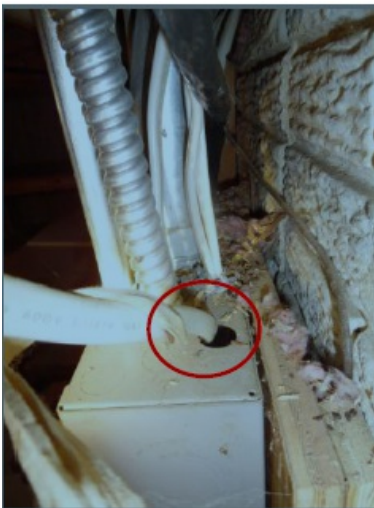
Marginal

Branch Wire is marginal, would need to have Double tapping and appears undersized for this unit.

Recommend installing additional receptacles/breakers In addition Open wiring not enclosed in appropriate junction boxes.

1. Electrical issues – recommend further evaluation/repair by a licensed Electrician with attention to the following items
 - o Main electrical panel
 - ☐ Appears to be undersized wire on circuit breaker # 24

- ☐ Double tapping present on circuit breaker #s 13, 24, 25 & 29
 - ☐ Missing retention clamps on romex at entry to cabinet
 - ☐ Improper attachment of dead front cover
